# ***BROOME COUNTY WATERSHED FLOOD HAZARD MITIGATION PLAN***

Woidt Engineering & Consulting, PC  
41 Chenango Street, Suite 200  
Binghamton, NY 13901

May 2016

***BROOME COUNTY  
WATERSHED FLOOD HAZARD  
MITIGATION ANALYSIS***

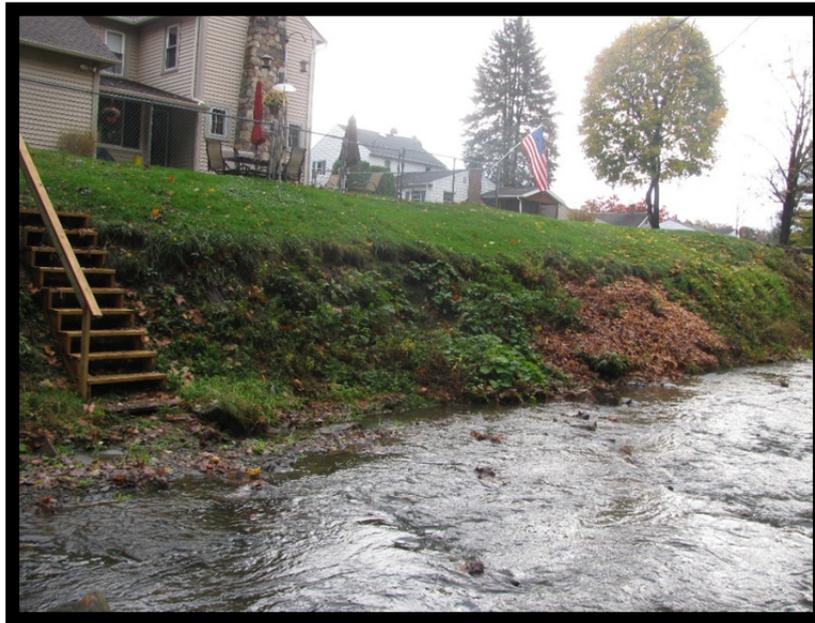
Mitigation Site 1 is located 100 feet upstream of the Smith Drive Bridge over Patterson Creek as seen in Figure 13 and there is one erosion hazard located at Mitigation Site 1 (B-36, Appendix B). The drainage area to Site #1 is 6.5 square miles whose largest land use type is forested area (53%). The drainage area contains 4.8% impervious cover (per 2011 National Land Coverage Dataset (NLCD)). Patterson Brixius Grey Watershed 1 Flood Control Dam (State ID: 086-3457) is located upstream of Mitigation Site #1 which reduces flood discharges by storing flood waters for 4.5 square miles (70%) of the watershed. The dam is a high hazard class "C" dam and was studied by detailed hydrology and hydraulic modeling methods. The erosion hazard consists of a 600' long eroding left bank (east bank of the creek) that is composed of a silty sand soil material with bank angles that approach near vertical and average 8 'in height. There is very little to no riparian corridor along the top of the stream bank and therefore there is very low root density along the stream bank toe to provide bank cohesion and resistance to erosion. A typical bank section can be seen in the photo below.

*Looking East at Erosion Hazard at a Private Home.*

A stable bank angle for this material type is a 3 horizontal to 1 vertical. A silty sandy soil and low root density (such as planted with sod) will begin to erode when velocities exceed 1.0 ft/second (referred to in this report as incipient velocity).

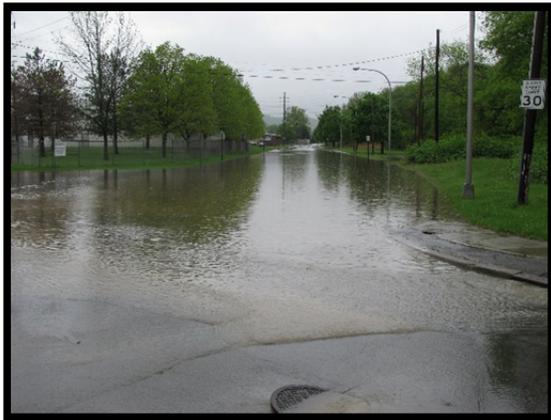
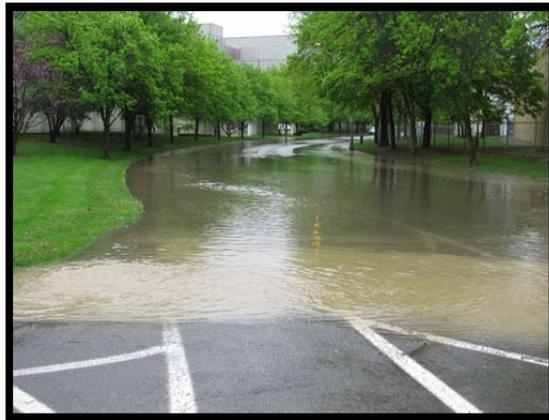
Frequent flooding occurs along sections of East Franklin Street, Clark Street, Oak Hill Avenue and areas within the Huron Campus during periods of heavy rainfall. The area along East Franklin Street and Clark Street is the area that is most chronically affected with street flooding occurring even after moderate rainfall events. The photos below were taken on May 9<sup>th</sup>, 2014 after a rainfall event of approximately 1.3 inches of total rainfall. Residents and Huron Campus staff have reported that the existing stormwater sewer system in these areas frequently back up through the inlets and manholes, resulting in street flooding and sheet flow flooding of adjacent homes and properties. Ponding of stormwater within the travel lanes of public roadways also creates a public safety issue and potential liability to the Village of Endicott. The affected areas along Clark Street and East Franklin Street require the placement of barricades and flares by Village Police to prevent vehicular/pedestrian traffic from entering flooded areas. It is estimated there are 4,000 one-way vehicle trips on Clark Street and East Franklin Street.

*Robble Ave/Clark Street, view east*

*Robble Ave/East Franklin Street, view west*
